# HEDGE MANAGEMENT PLAN FOR SAINT-GAUDENS NATIONAL HISTORIC SITE

CORNISH, NEW HAMPSHIRE

Olmsted Center for Landscape Preservation  
National Park Service, Boston, Massachusetts, 2008

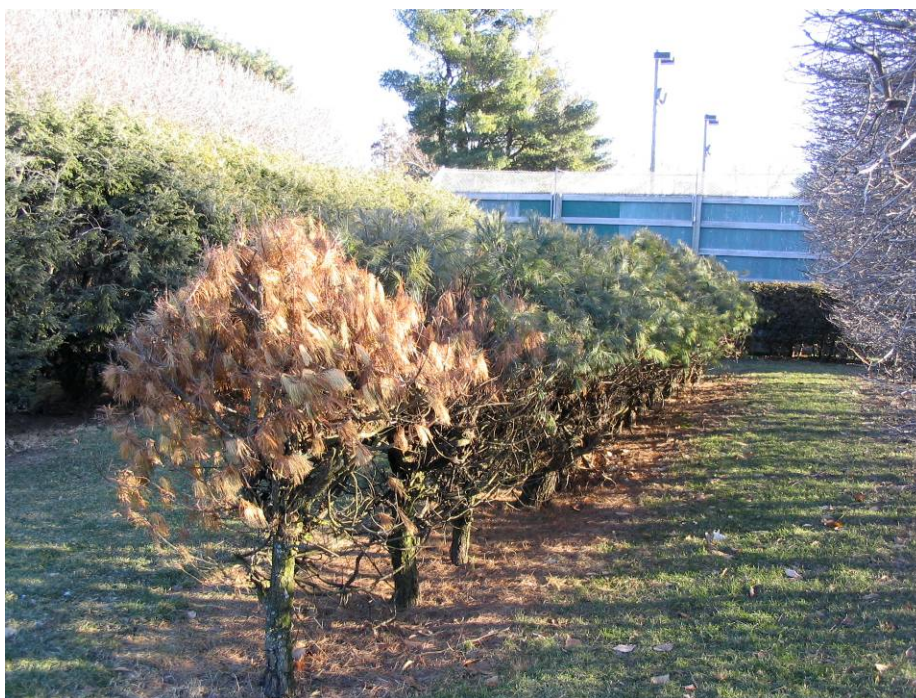
**Figure 0.4: A current view of the same white pine hedge as shown in figure 0.3, illustrating loss of lower canopy most likely due in part to increased level of shade, 2006 (SUNY ESF).**

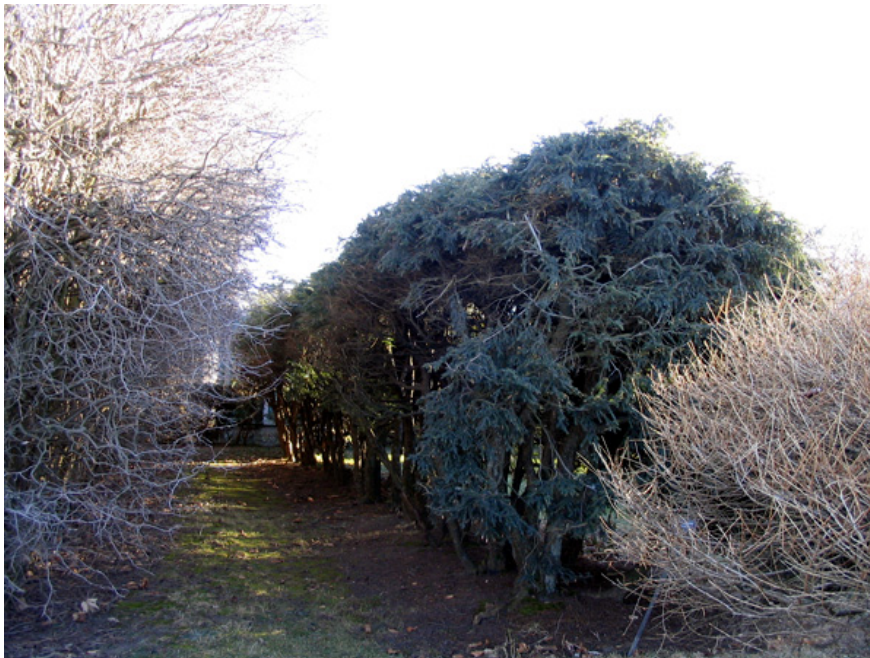
Figure 0.6: Hemlock hedge (similar to figure 0.5) at the Canadian Central Experimental Farm in Ottawa, planted in 1889, photographed 2007. Note loss of side canopy, probably due from excessive shade from adjoining hedge (SUNY ESF).

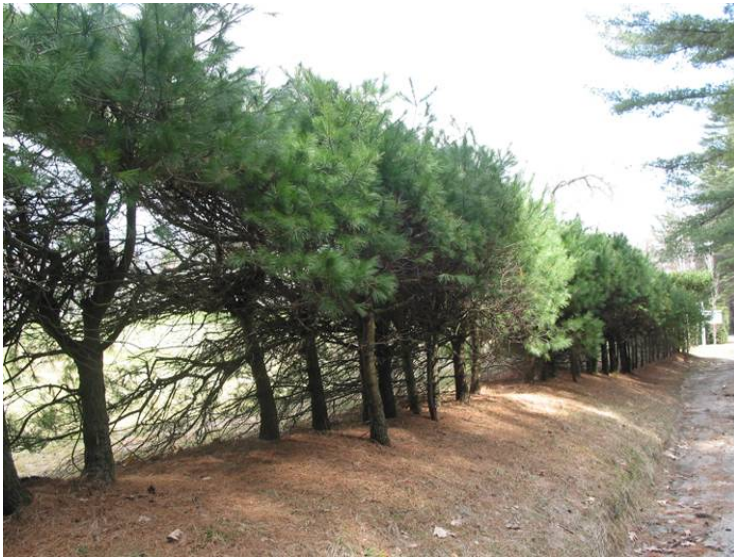
**Figure 3.1:** West meadow hedge, view looking east along Saint Gaudens Road showing character of c.1970 plants thirty-six years after planting, 2006. Note bare side canopy on the road side (right) and lack of even canopy (Olmsted Center for Landscape Preservation).

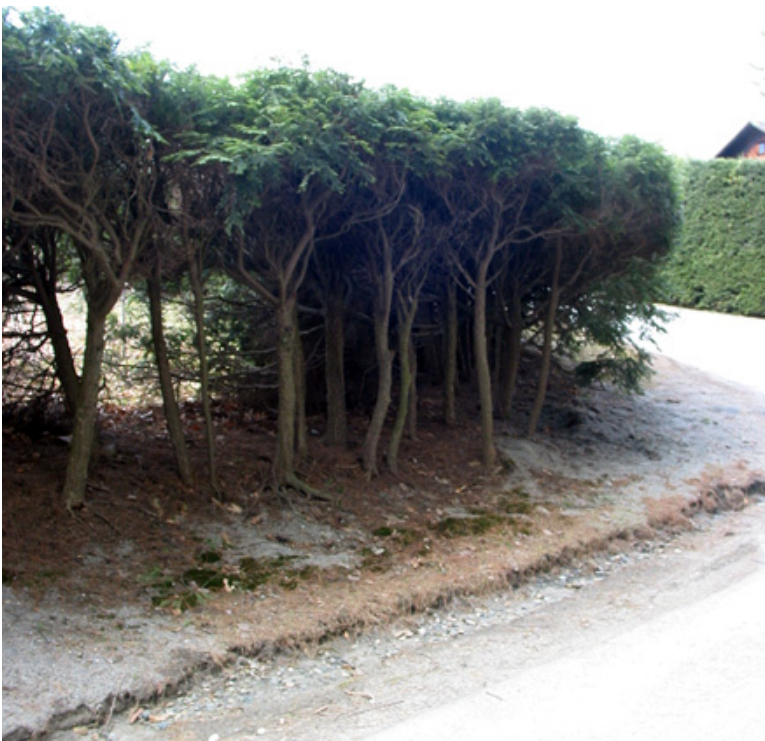
**Figure 3.10:** The cutting garden hedge, view looking northeast at bare understory of section H-5 facing Saint Gaudens Road, 2006. The gray sediment is left over from winter snowplowing (Olmsted Center for Landscape Preservation).

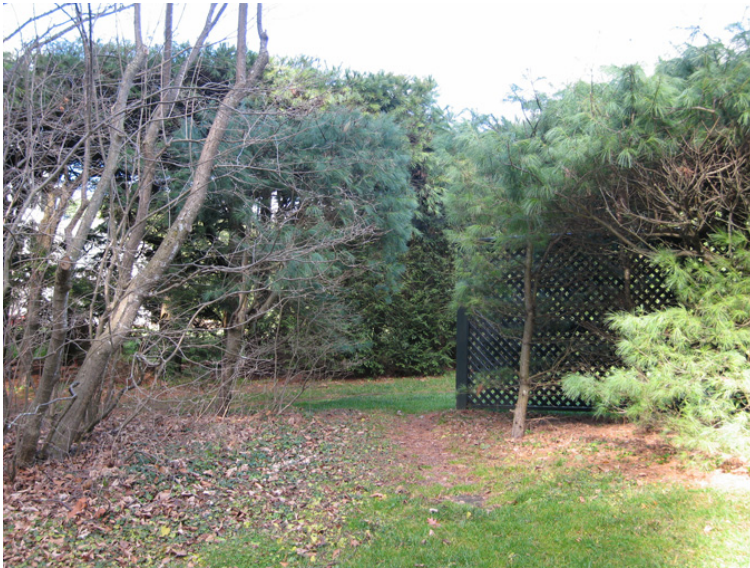
**Figure 3.11:** The cutting garden hedge, view looking northwest at the gap in the west end of section H-6, 2006. Note the Japanese tree lilac hedge at left and the kitchen hedge in the background (SUNY ESF).

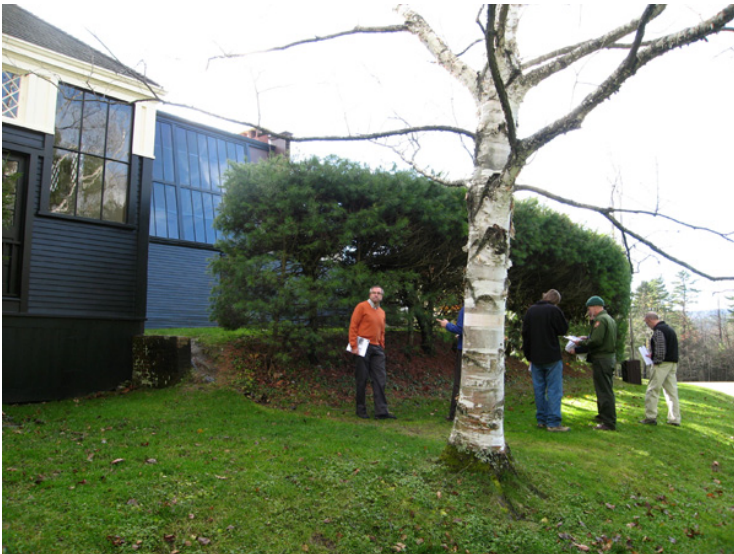
Figure 3.20: The Little Studio hedge view looking west showing non-historic alignment and opening, 2006. (SUNY ESF)

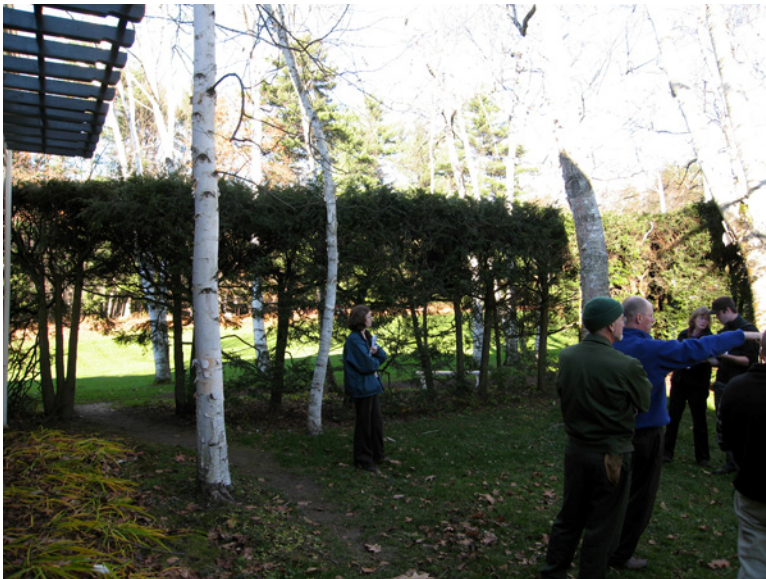
Figure 3.23: The Pan grove hedge, view looking north at section H-10 showing weak canopy and non-historic opening/path, 2006 (SUNY ESF).

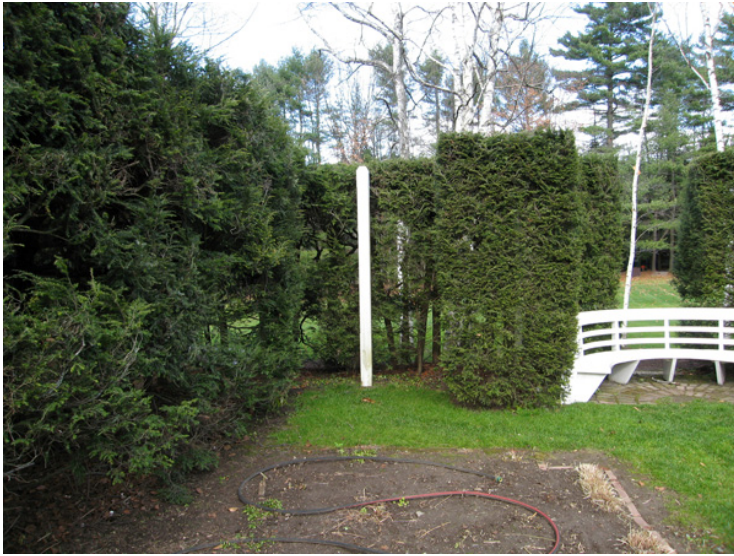
**Figure 3.28:** The terrace garden hedge, view looking north at a detail of H-12, 2006. Note curved alignment around bench, recess around post, and weak side canopy (SUNY ESF).

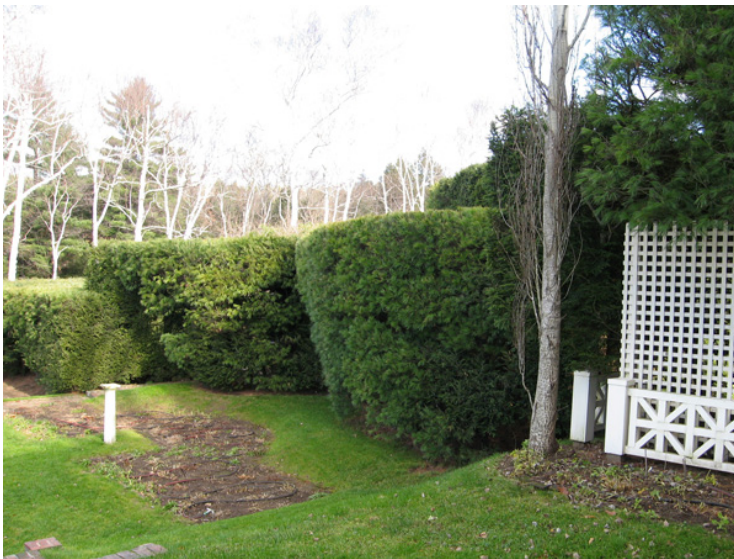
**Figure 3.29:** Section H-13 of the terrace garden looking northeast from the upper terrace, 2006. Note inward batter toward the base and convex alignment (SUNY ESF).

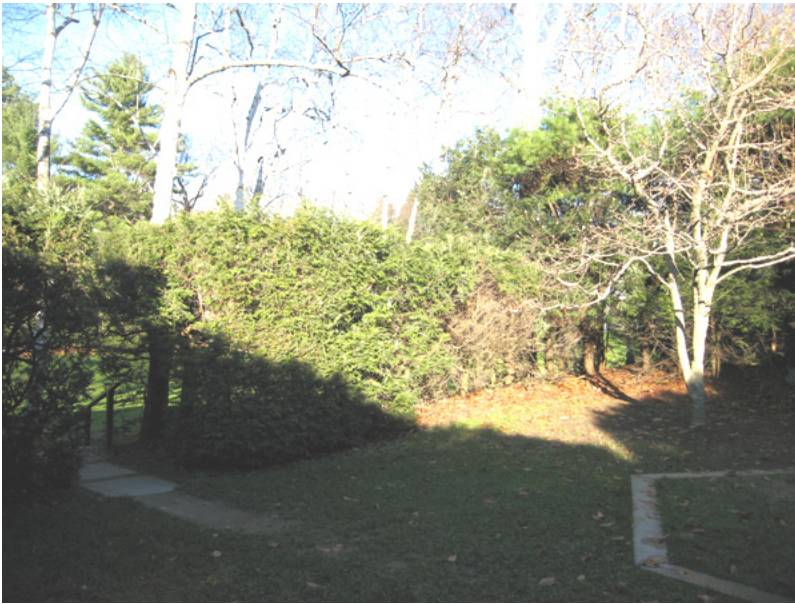
**Figure 3.31: The Adams hedge, view looking northeast at sections H-15 and 17, 2006. Note weak canopy and recent dieback from shade of the magnolia tree, and shade cast from adjoining sections (SUNY ESF).**

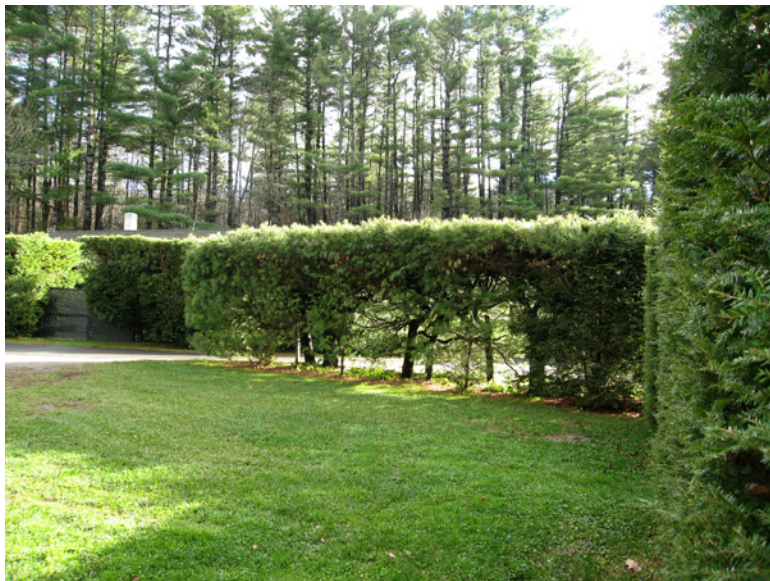
**Figure 3.38: The Shaw hedge, view looking south at dogleg (H-20) showing weak lower canopy, 2006 (SUNY ESF).**

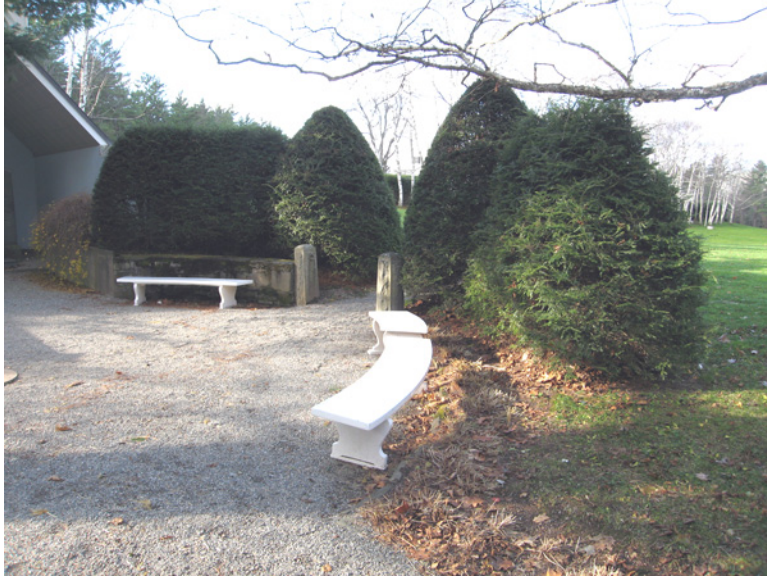
**Figure 3.41:** The galleries entrance hedge, view looking southwest from interior of courtyard, 2006. The missing north end of section H-23 is in the foreground (SUNY ESF).

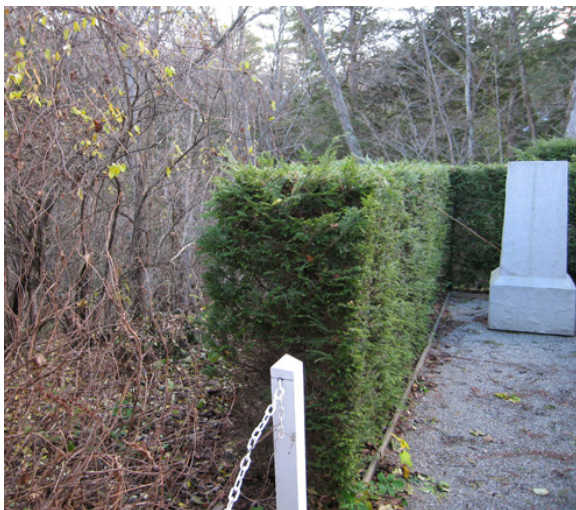
**Figure 3.43:** The north side of the Lincoln bust hedge, view looking east from Atrium showing encroachment of volunteer vegetation, 2006 (SUNY ESF).

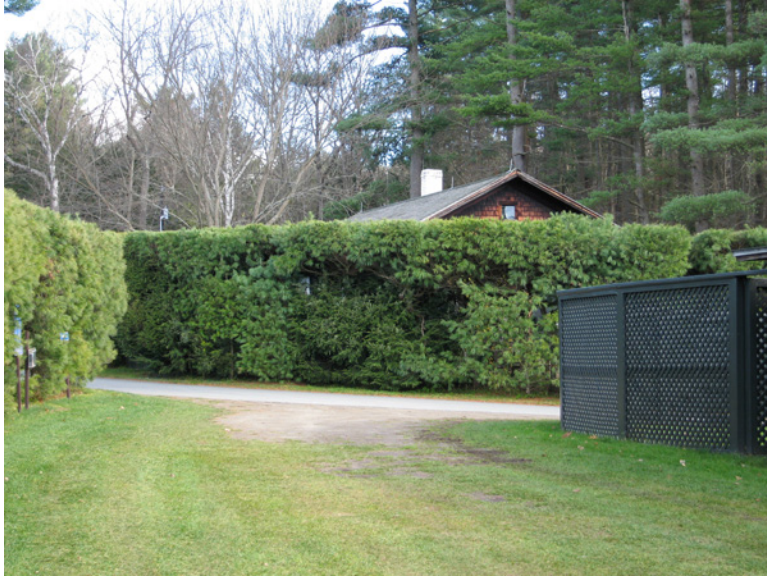
**Figure 3.47:** The Caretaker's Cottage hedge, view looking east from the stable, 2006. Note existing height above eaves of the cottage and mixed white pine-hemlock (SUNY ESF).
