# HEDGE MANAGEMENT PLAN FOR SAINT-GAUDENS NATIONAL HISTORIC SITE

CORNISH, NEW HAMPSHIRE

Olmsted Center for Landscape Preservation  
National Park Service, Boston, Massachusetts, 2008

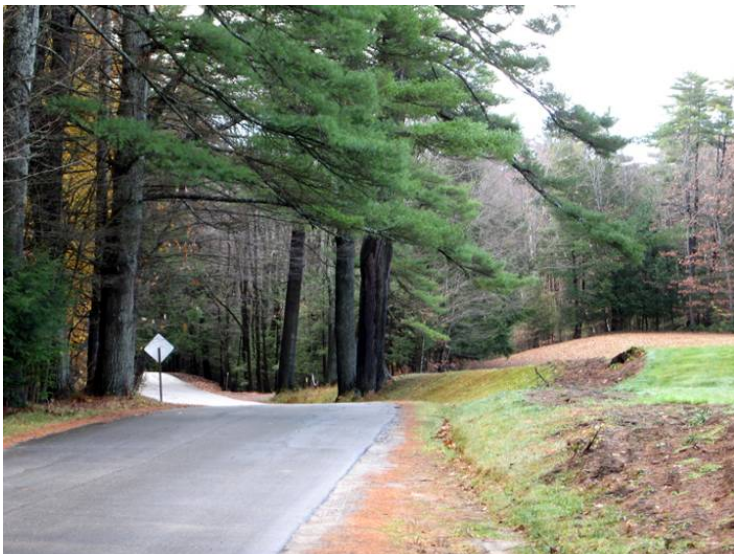
**Figure 3.2:** View looking west along Saint Gaudens Road showing site of west meadow hedge, 2006. The uphill alignment most likely dates to the c.1970 replanting. The mature white pines in the background are probably remnants of the original (c.1893-94) hedge (SUNY ESF).

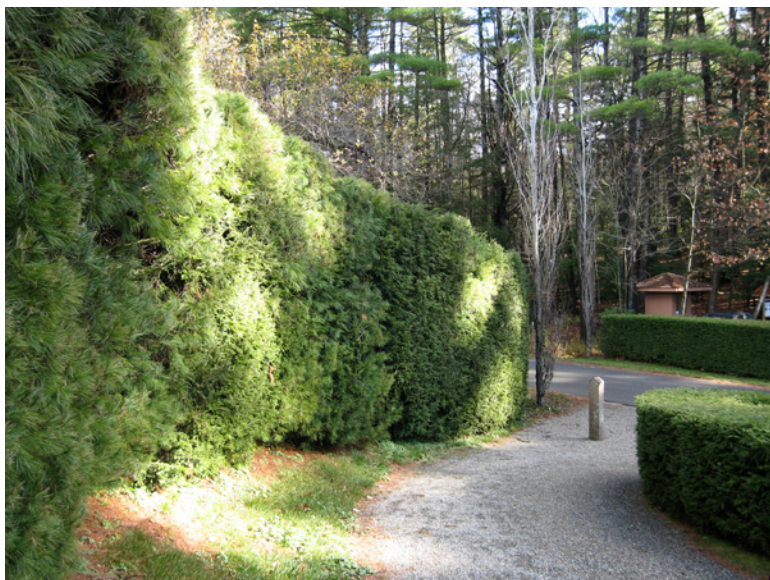
single row with 18-inch spacing. It is in good condition with a full, compact canopy (see Figures. 3.5, 3.6).

Figure 3.6: Horseshoe hedge, detail of east side of outer section (H-3) showing tapestry of white pine and hemlock, 2007 (SUNY ESF).

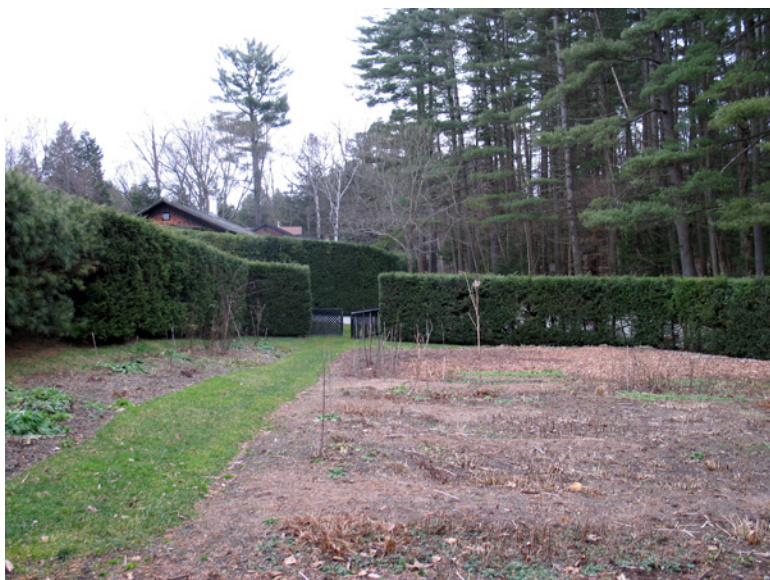
Figure 3.8: The cutting garden hedge, view looking east showing the opening at the service drive and the change from hemlock to white pine in section H-6 (left), 2006 (Olmsted Center for Landscape Preservation).

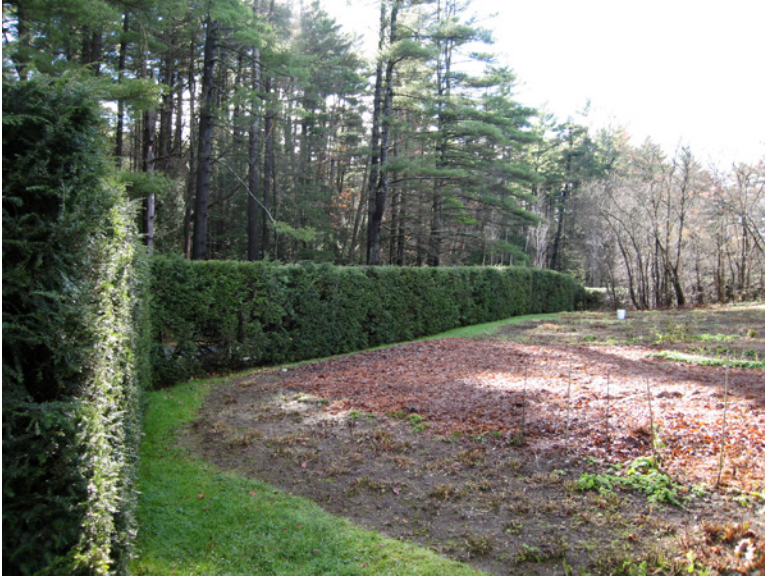
**Figure 3.9:** The cutting garden hedge, view looking west showing generally full side canopy on garden side of section H-5, with Japanese tree lilac grove in the background, 2006 (SUNY ESF).

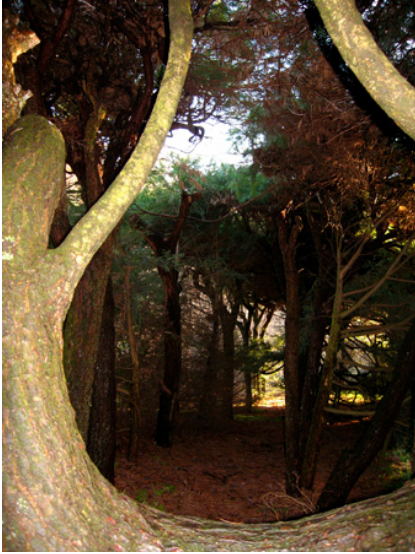
Figure 3.14: The kitchen hedge, view looking through the interior showing massive branching of aged hemlocks, 2006 (SUNY ESF).

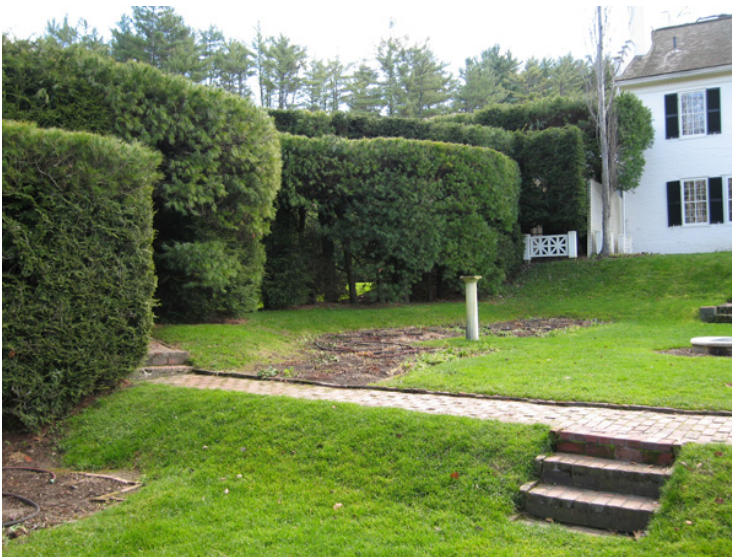
Figure 3.16: The kitchen hedge, view looking southeast at section H-8 extending above the terrace garden hedge (H-13) and stepping up adjacent to Aspet on the upper terrace, 2006 (SUNY ESF).

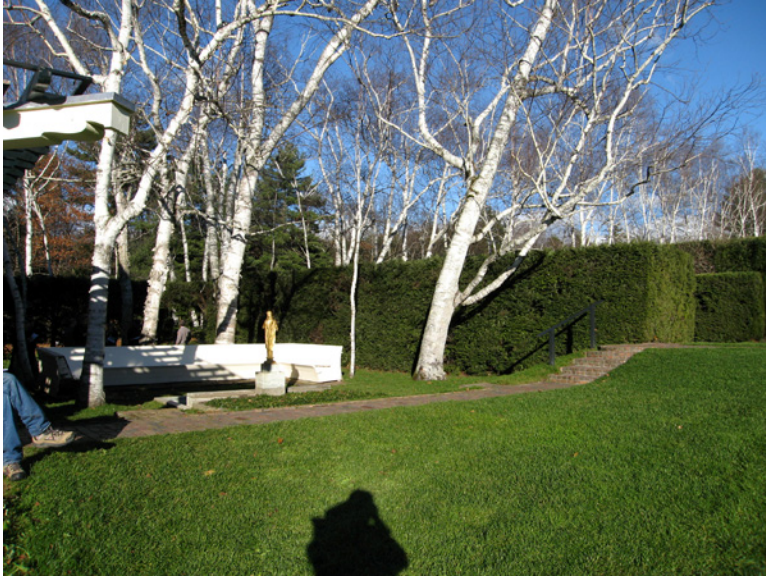
Figure 3.22: The Pan grove hedge, view looking northeast at section H-11 that forms the divide with the terrace garden, 2006 (SUNY ESF).

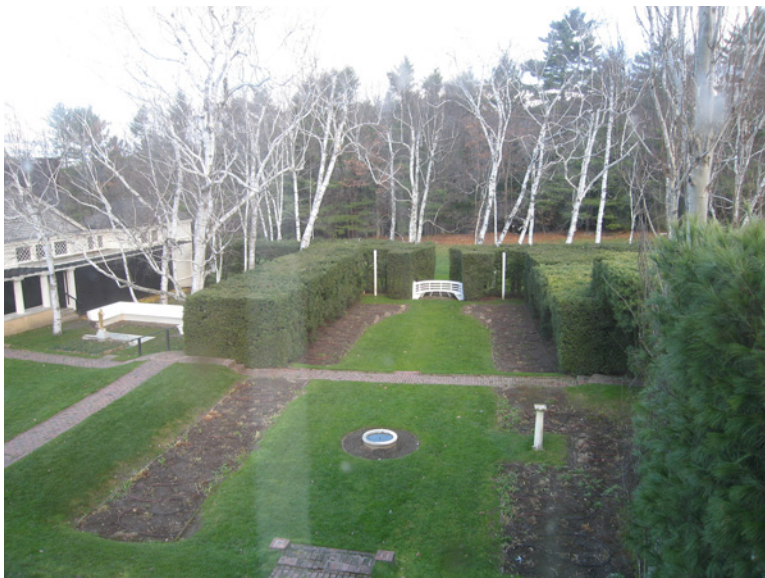
Section H-14 is a shared hedge with the terrace garden to the west. It is mixed white pine and hemlock, originally planted in c.1903 and later interplanted (see Figure 3.27). This section has a single row, and is 8 to 10 feet tall and 12 feet wide, with recent white pine interplanting on the Adams side that is not thriving apparently due to shade. It is full on the top but weak on the Adams and terrace garden sides.

**Figure 3.27:** Overview of the terrace garden hedge on the lower terrace looking north from the second floor of Aspet, 2006. Note the Pan grove hedge to the left and Adams hedge to the right (SUNY ESF).

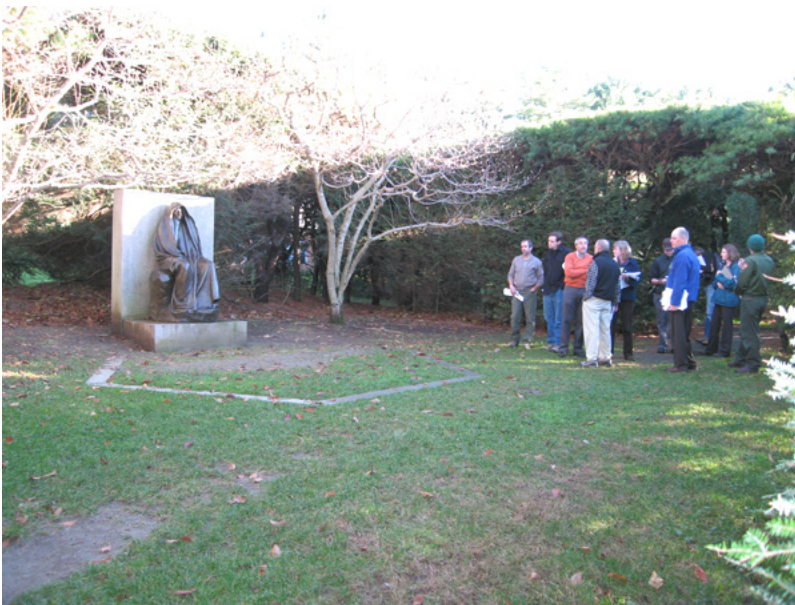
Section H-16, framing the south side of the Adams Memorial, is mixed white pine and hemlock planted in c.1893–94 with later interplanting. To the south, it frames the north wall of the Adams vestibule. This section has a single row with later infill along the hedge, and is 10 feet tall, 6 feet wide, with a non-historic arched opening from the Adams vestibule. It rises above adjoining section H-14, is level with the adjoining H-13 (terrace garden hedge), and is lower than H-17 (Adams-Shaw divide). Section H-16 has a mostly full canopy with weak areas around the arched opening and in the shade of the magnolia (Figure 3.32).

Section H-17, forming the east wall of the Adams Memorial and the divide with the adjoining Shaw Memorial, is mixed white pine and hemlock planted in c.1893–94 with later interplanting. It is a double row with infill along the edges (see Figures 3.31, 3.32). This section rises above all other adjoining hedge sections at 18 feet tall. It consists of several very large, aged hemlock trees, with an overall width of 10-12 feet. The hedge is weak on the Adams side, with approximately three-quarters of its side canopy lost due primarily to heavy shade from the adjoining magnolia trees flanking the Adams Memorial.

**Figure 3.32: The Adams hedge, view looking southeast at sections H-16 and 17, 2006 (SUNY ESF).**

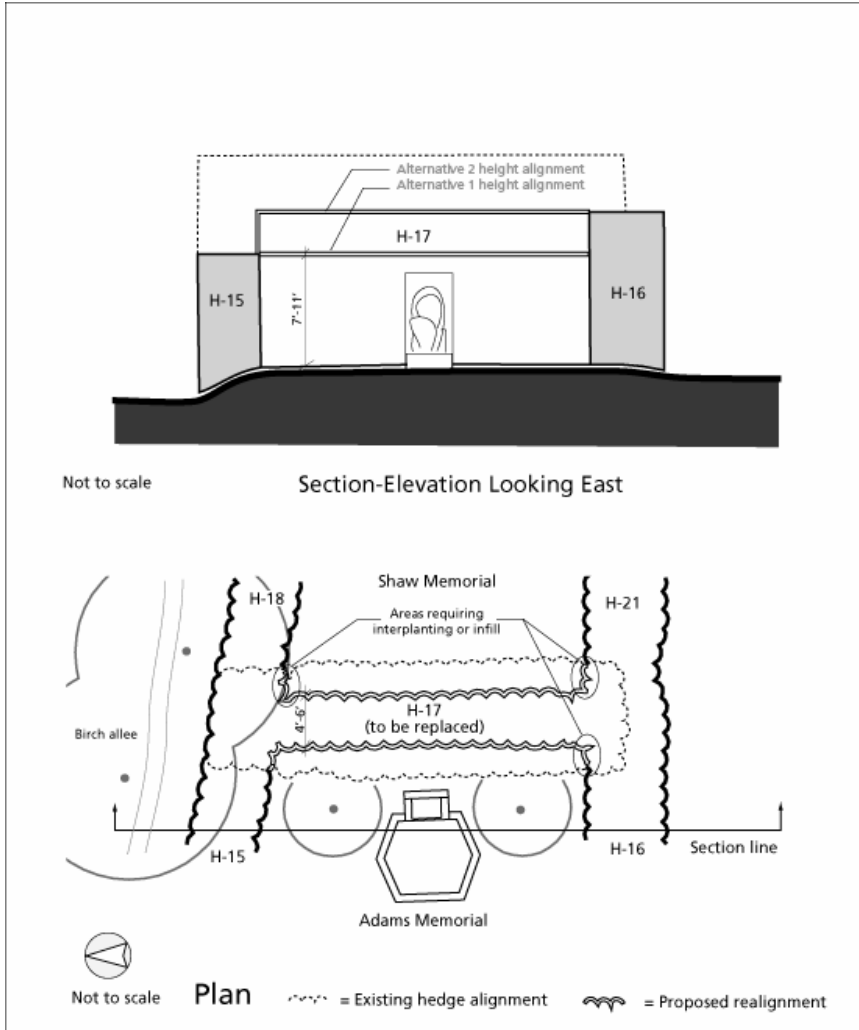
Figure 3.33: Plan and section-elevation detail of H-17 and adjoining sections in the Adams and Shaw hedges showing proportional relationships (SUNY ESF).

The existing location and alignment of this hedge is generally correct. The northern extension of H-17 over H-15 and H-18 (facing the birch allee) and over H-16 and 21 to the south appears to be a non-historic condition, and therefore this extension should be removed and the hedge kept to the interior sides of the adjoining hedges (Figure 3.33).

Section H-16 should align in height with section H-21 in the Shaw hedge and H-13 on the middle terrace of the terrace garden hedge, as it does now. Sections H-14 and H-15 should align in height with adjoining sections H-12 and H-15 bordering the birch allee. There are two alternatives for the alignment of section H-17 (see Figure 3.33):

extensions should be removed and the hedge kept to the interior face of the adjoining hedges (see Figure 3.33).

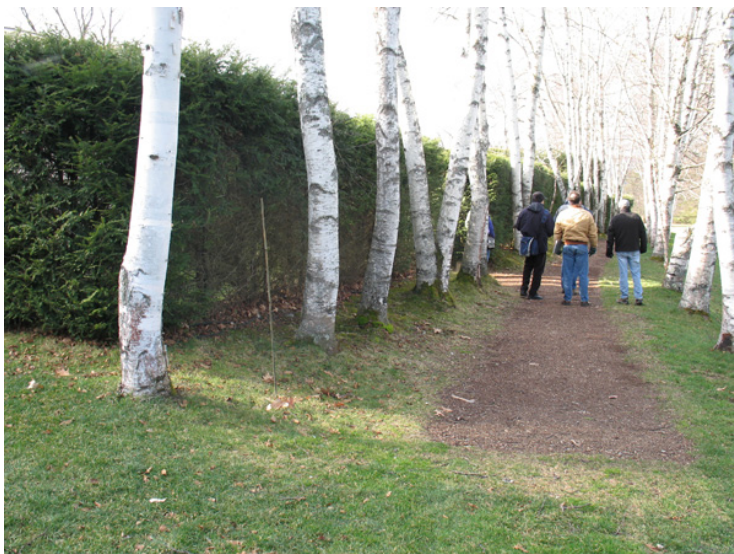
Section H-18, forming the north side of the Shaw along the birch allee, is pure hemlock planted in c.1950 (Figure 3.36). It is a single row with plants spaced between 2 and 6 feet. The section is 8 to 10 feet tall and 8 feet wide, and the east end of the section abuts a non-historic opening. It aligns in height with the adjoining north side of the Adams hedge (H-15), but is approximately 5 feet lower than the Adams-Shaw divide (H-17). The section has a full and dense canopy on the Shaw side, but a thinner side canopy on north side mostly due to shading from the birch allee (Figure 3.37).

**Figure 3.37: The Shaw hedge, view looking west showing a representative view of the relationship between the hedges and birch alley, 2007 (SUNY ESF).**

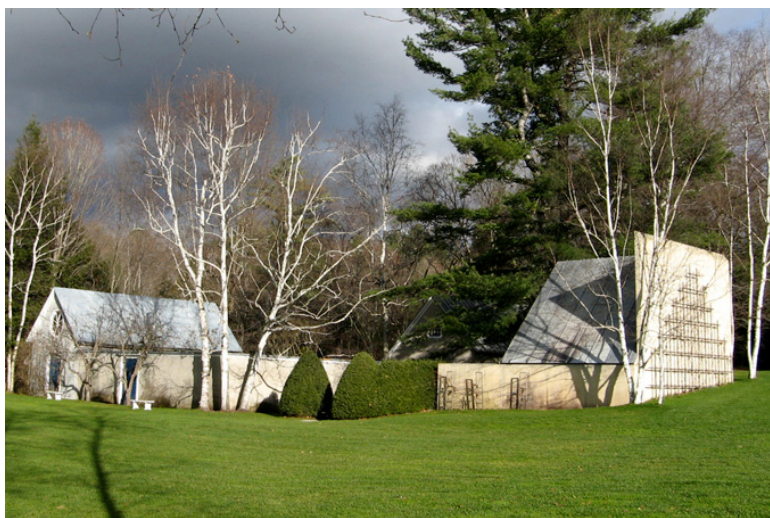
**Figure 3.40: The galleries entrance hedge, view looking northeast with Farragut pavilion at right, 2006. Note height of linear section compared with cones. (SUNY ESF).**

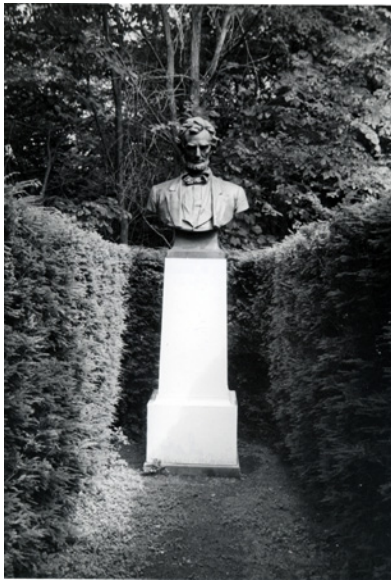
Garden, on axis with a walk extending from the Atrium. The walk was lined by hemlock hedges that were maintained at the height of the sculpture pedestal, approximately 5 feet tall (Figure 3.42). Hemlock hedges were also planted to frame the adjoining space between the walk and the Picture Gallery. The function of this adjoining room is not known, although it may have been intended as additional display space for sculpture.

**Figure 3.42:** The Lincoln bust hedge, view looking east from Atrium, c.1965 (Saint-Gaudens National Historic Site, photograph 1270).

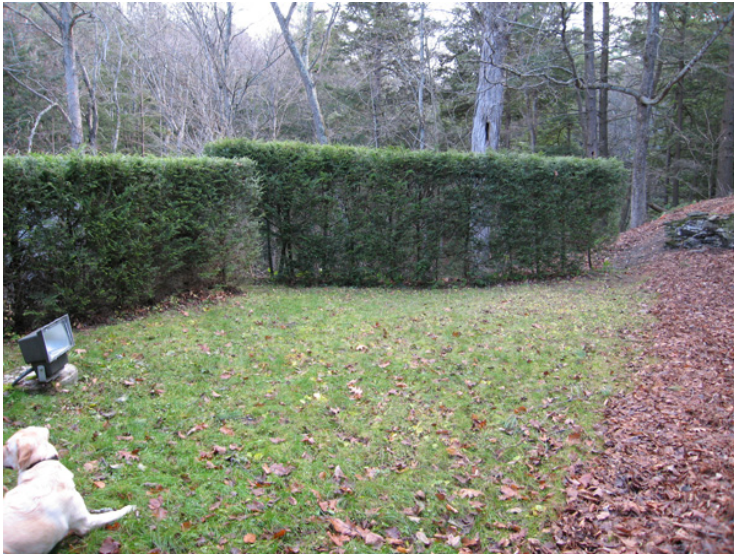
**Figure 3.44:** The Lincoln bust hedge, view looking east at sections H-25 and 26, 2006. The site of the south leg of H-26 removed in 2006 is the bed at right (SUNY ESF).

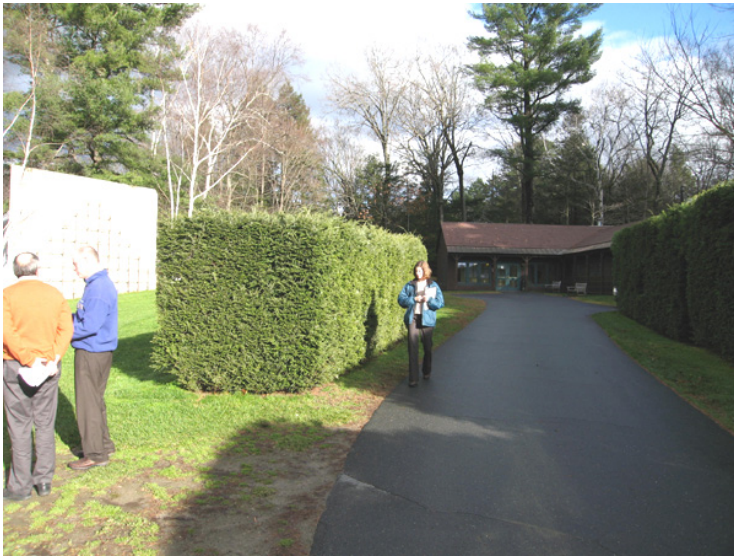
plants (Figure 3.45). It is in excellent condition, with a compact, full canopy. The hedge screens views from the visitor center (former maintenance building) to the north and west.

**Figure 3.45:** The visitor center hedge, view looking east with visitor center in the right background and Farragut pavilion to the left, 2006 (SUNY ESF).

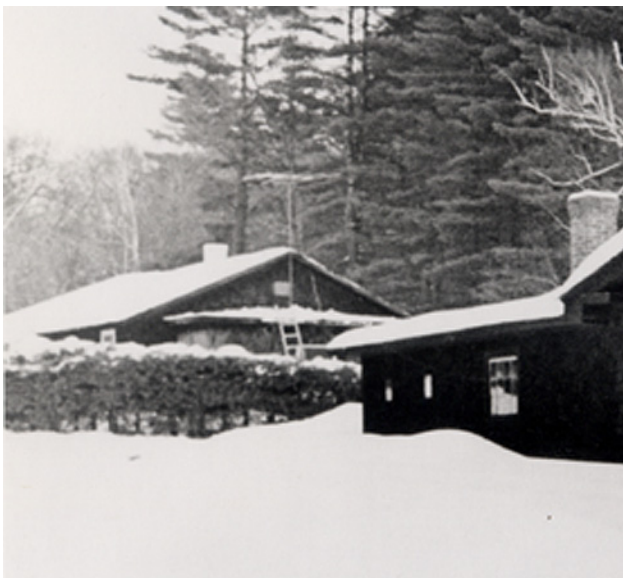
By the mid-1960s, the older section of the hedge extending along the service drive was being maintained at about the height of the eaves of the Caretaker's Cottage (Figure 3.46). In later years, this section grew upwards of 12 feet, concealing all but the upper gable of the cottage when looking from the exterior of the hedge. In c.1980, the section along the road (all or part of H-28) was replanted in hemlock.<sup>82</sup> This section did not develop strongly most likely due to shade from the woods across the road. In c.2000, a small section of the hedge near the curve along the service drive was replaced due to snow damage.

**Figure 3.46:** The Caretaker's Cottage hedge, view looking east from the stable showing height after the historic period, c.1970. Note that the hedge was lower than the eaves of the cottage (Saint-Gaudens National Historic Site, photograph 20).

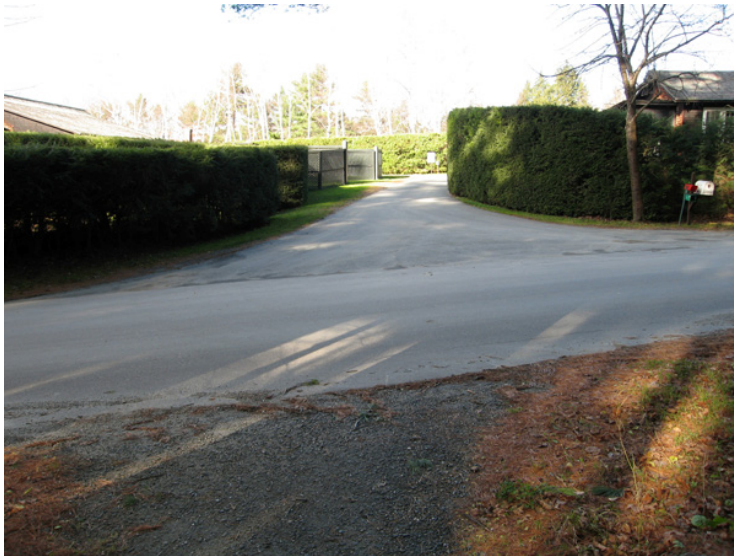
Section H-27, forming the north and west sides of the hedge extending around the curve at the corner of the service drive and Saint Gaudens Road, is mixed white pine and hemlock planted between c.1917 and 1927 with later infill (Figures. 3.47, 3.48). It is 10-12 feet tall and 10 feet wide, planted in a single row with 1 to 3 feet spacing between plants. It is taller than the companion cutting garden hedge on the opposite side of the service drive (see Figure 3.48). The section has three openings: one at the entrance walk to the Caretaker's Cottage, a second to the north of the cottage that is closed by a gate, and a third non-historic narrow arched opening near the east end of the hedge. It has a dense canopy that is mostly full but has some bare spots between the hemlock and white pine. The southeast end of the section, adjoining H-28, was replanted in hemlock in c.2000 as a result of damage from snow.

**Figure 3.48:** The Caretaker's Cottage hedge, view looking north up the service drive, 2006. Note difference in height compared to cutting garden hedge to left of drive (SUNY ESF).

- Lower Caretaker's Cottage hedge (H-27) to height below eaves of cottage
- Lower Galleries entrance hedge and extend missing part (H-22, 23)
- Lower height of kitchen hedge and address bare understory of dogleg (H-7, 8)

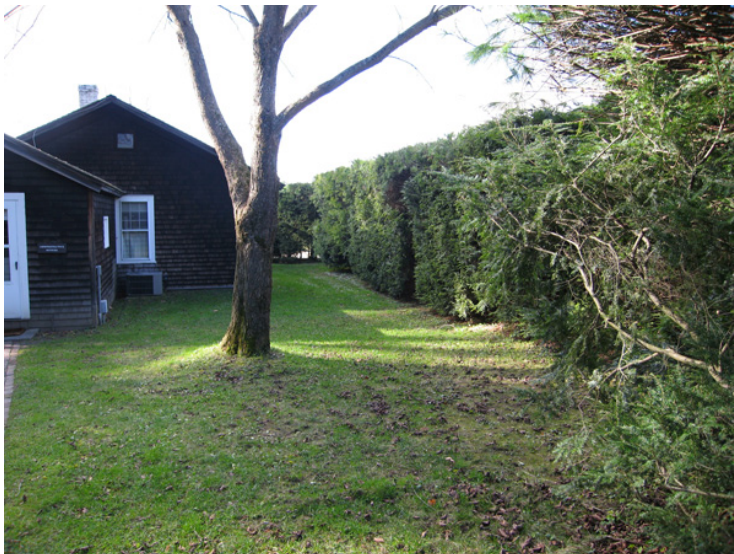
**Figure 3.49:** The Caretaker's Cottage hedge, view looking west of interior of H-27 showing relationship to scale of cottage, 2006 (SUNY ESF).

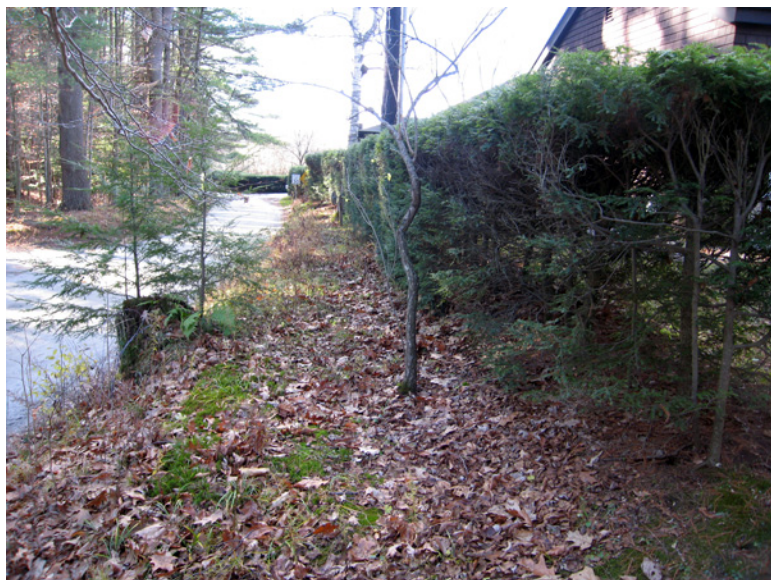
Section H-28, extending along Saint Gaudens Road, is pure hemlock replanted in c.1980 (Figure 3.50). It ranges from 8 feet tall at section H-27 to 5 feet tall to the rear of the garage and visitor center, and averages 4 feet wide. The hedge is full facing the Caretaker's Cottage yard, but is weak on the remainder of the hedge, with gaps and bare areas. The hedge is heavily shaded from the woods south of the road as well as several adjoining trees on the north side, and is situated at the top of a steep bank that is eroding.

**Figure 3.50: The Caretaker's Cottage hedge, view looking west from the east end of the hedge along Saint Gaudens Road, 2006 (SUNY ESF).**

- Replace roadside hedges when the woods south of Saint Gaudens Road are cleared back to increase light levels (H-2, 3, 5, 28)

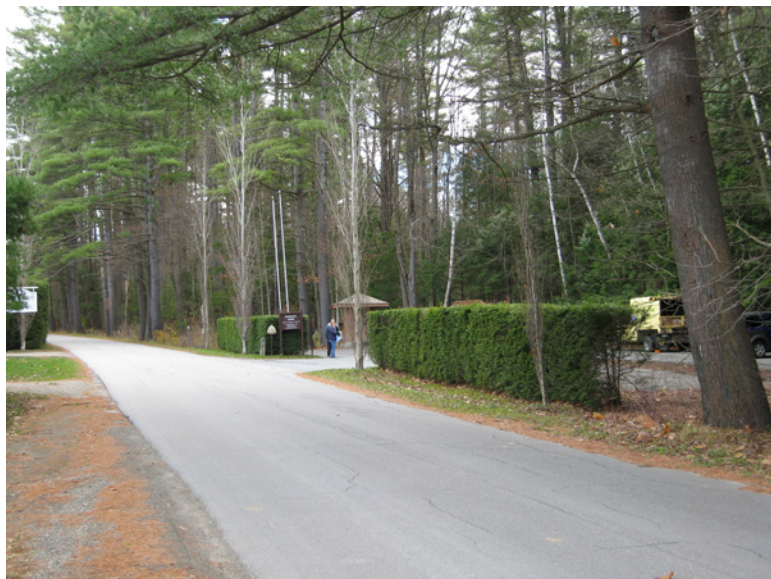
The parking lot hedge, consisting of two symmetrical sections flanking the entrance to the parking lot parallel to Saint Gaudens Road, is pure hemlock planted in c.1988 (Figure 3.51). Each section is 5 to 6 feet tall and 3 feet wide, and is planted in single rows. The hedges are in part shade from the adjoining woods, and each section is flanked on the road side by two Lombardy poplar. Overall the hedges have a full, dense canopy, except for the more heavily shaded interior southwest end of H-30.

**Figure 3.51: The parking lot hedge, view looking east along Saint Gaudens Road, 2007. The white pine at the right is recommended for removal because of the heavy shade it casts on this hedge (and Lombardy poplar) and the horseshoe hedge (SUNY ESF).**
